# Site Inspection Report

Final site inspection

07.10.2021

004

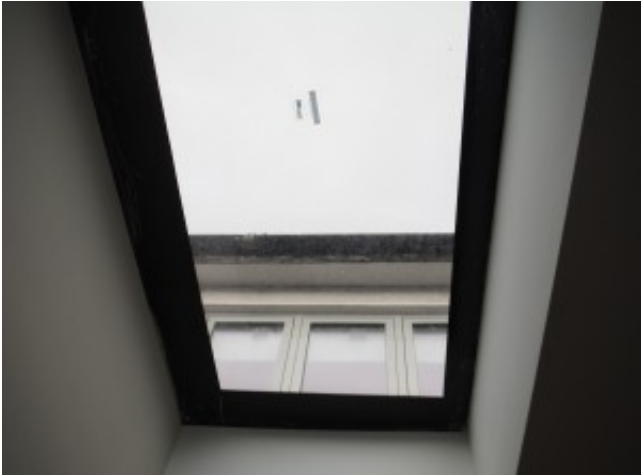
# 004 / 001

Clean all skylights and remove protective film

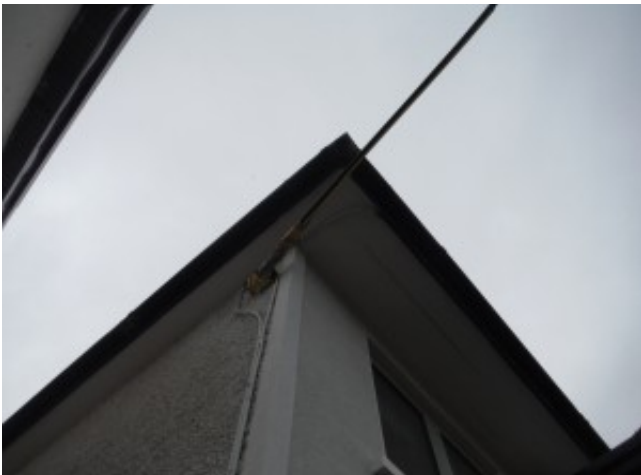
# 004 / 002

Remove protective cover from power cables. This is a job for the ESB. This may be a legacy issue from work next door?

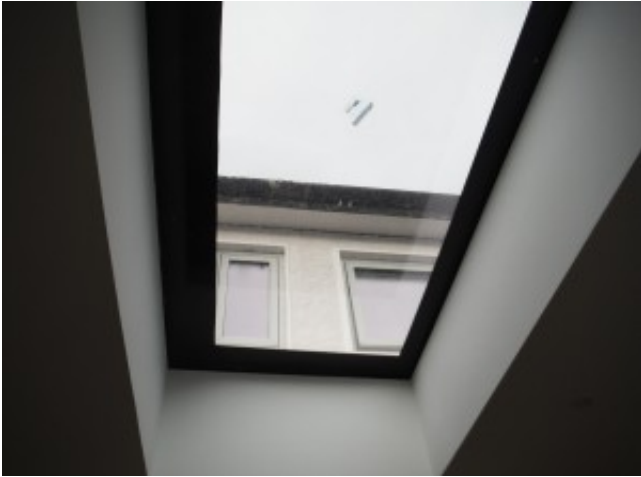
# 004 / 003

As above remove film and clean skylight

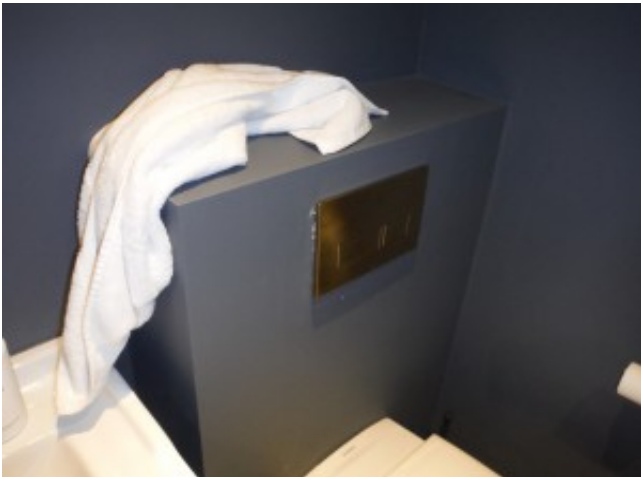
# 004 / 006

Poor finish around flush unit in downstairs bathroom.

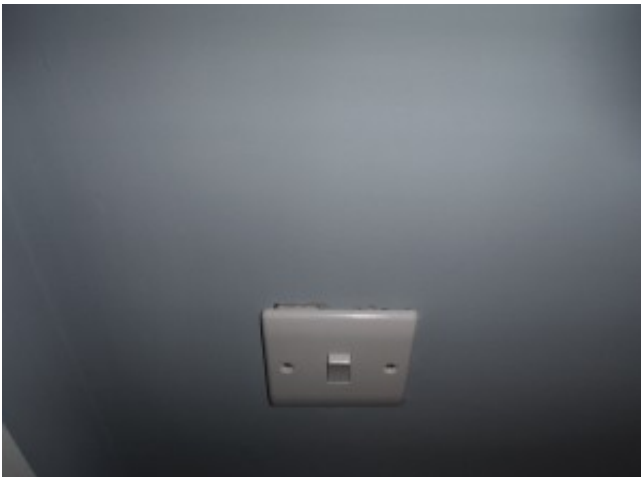
# 004 / 007

Poor finish around light switch in front lining room.

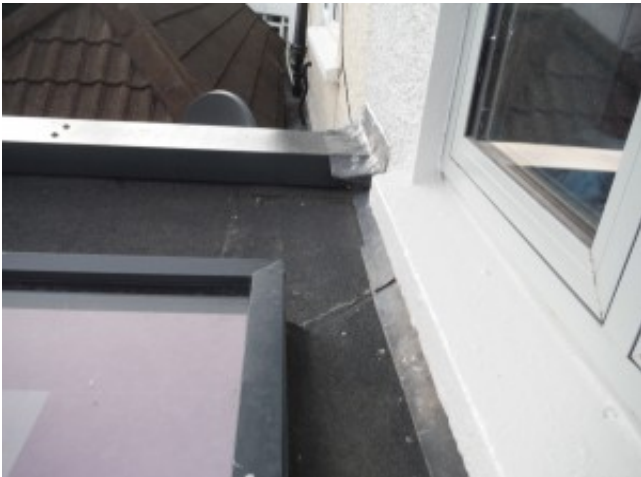
# 004 / 010

Flashing to be tidied

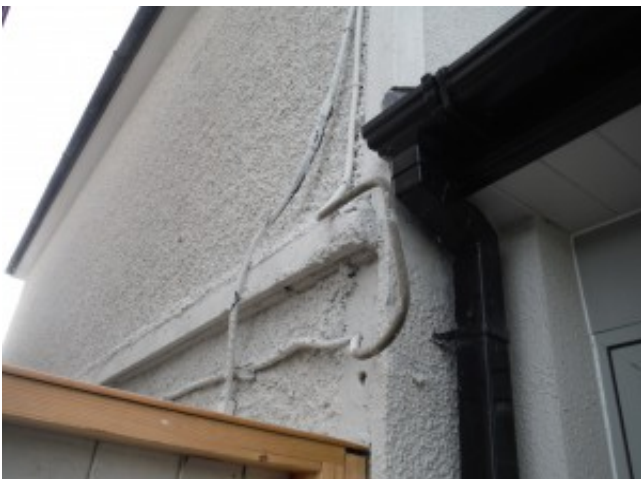
# 004 / 011

Power supply cable needs to be tidied. Could be tied in with ESB removing protective film and Conor asked about the possibility of replacing the cover to the meter box. Might not be easily done.

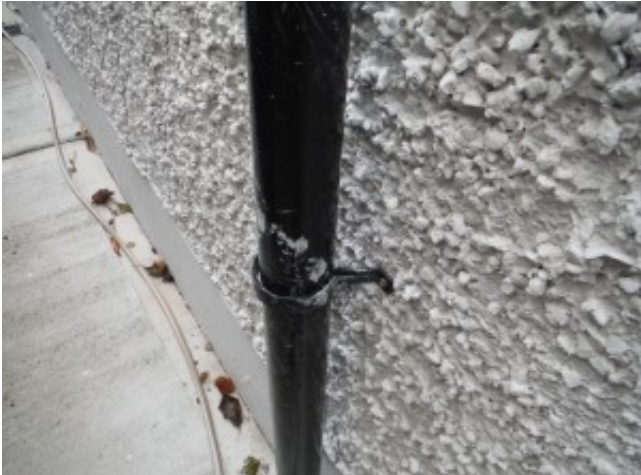
# 004 / 012

Paint splashes on down pipe

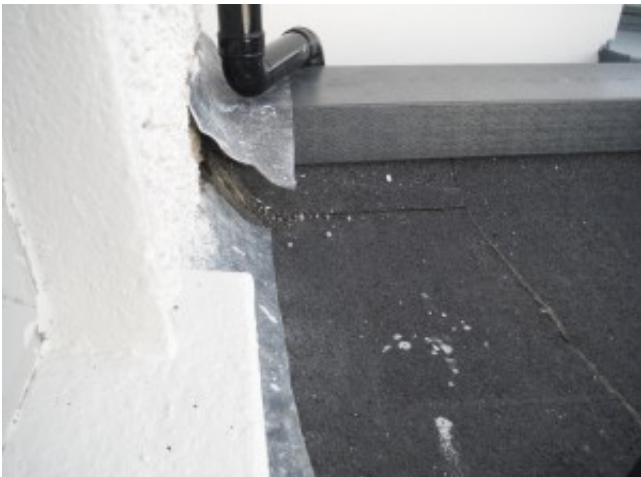
# 004 / 013

Flashing needs to tidied

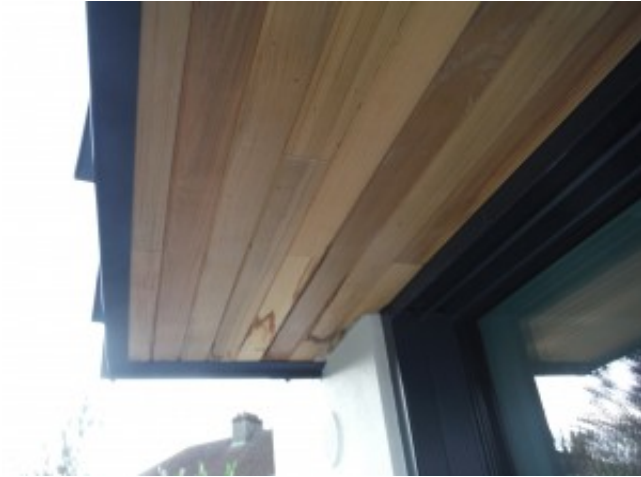
# 004 / 014

There was a question in relation to the fascia and soffit and whether it was to be painted or not.

I'm not sure what the discussion was but it really should be dealt with. The paint is peeling and the timber is going to be exposed.

Sodffit timber to be treated.

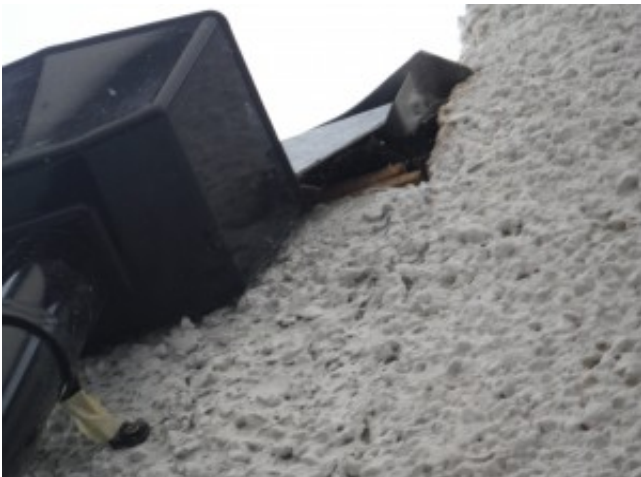
# 004 / 015

Timber exposed above hopper head this needs to be sealed.

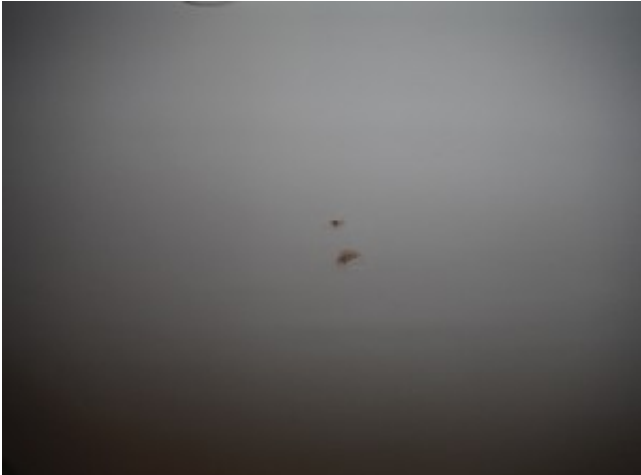
# 004 / 016

Painting snags throughout which is a work in progress.

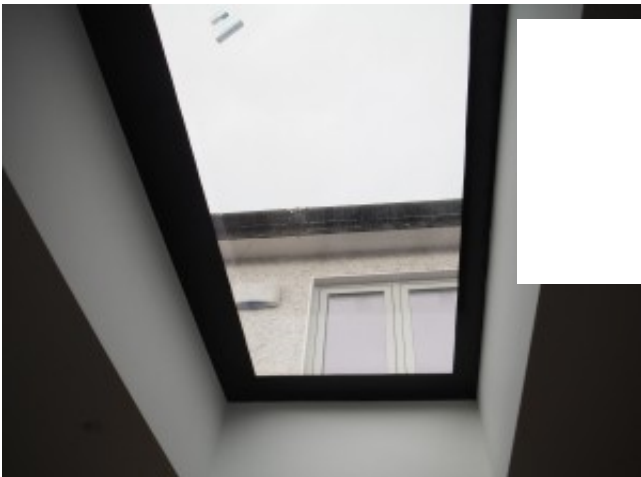
# 004 / 018

Film to be removed and stickers and glass cleaned.

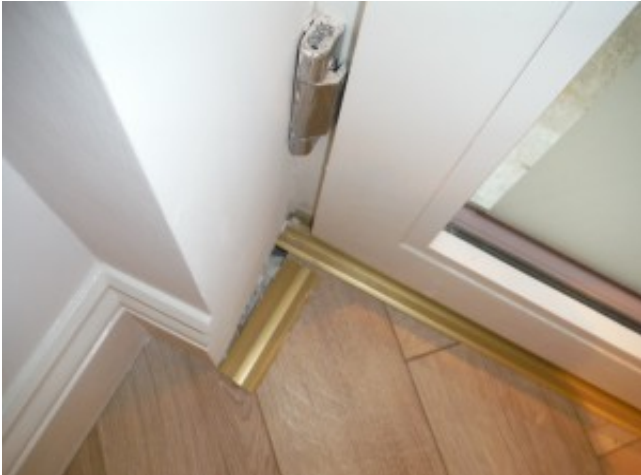
# 004 / 021

Flooring to be finished into corner at external utility door. Hinges need cleaning of paint spills.

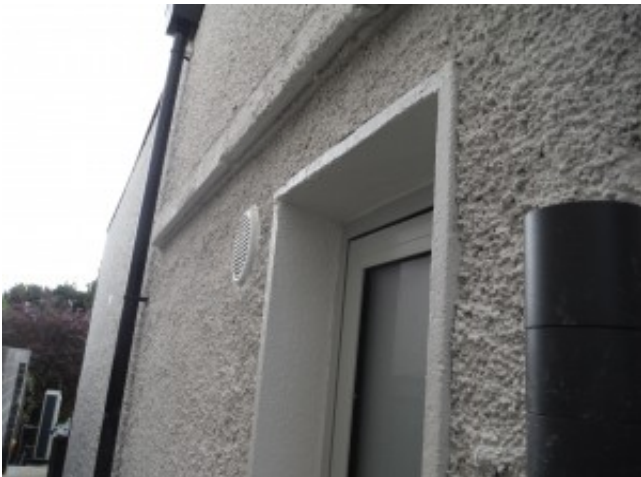
# 004 / 024

Vent for mechanical extraction in utility is installed but fan not installed. This is a requirement under current building regulations.

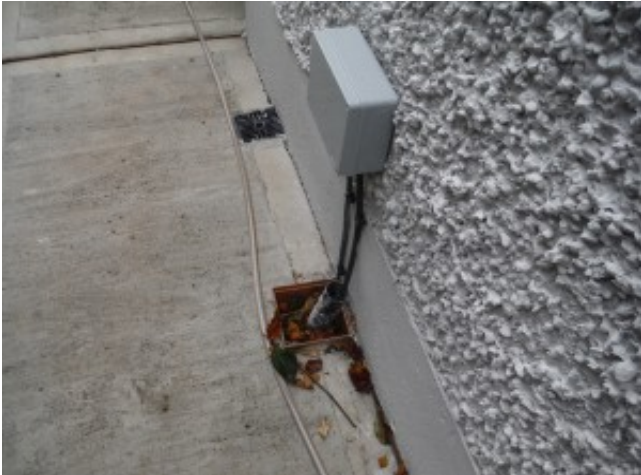
# 004 / 026

Lid required to cover where pipe exits the riser. to stop leaves and other rubbish collecting in the opening.

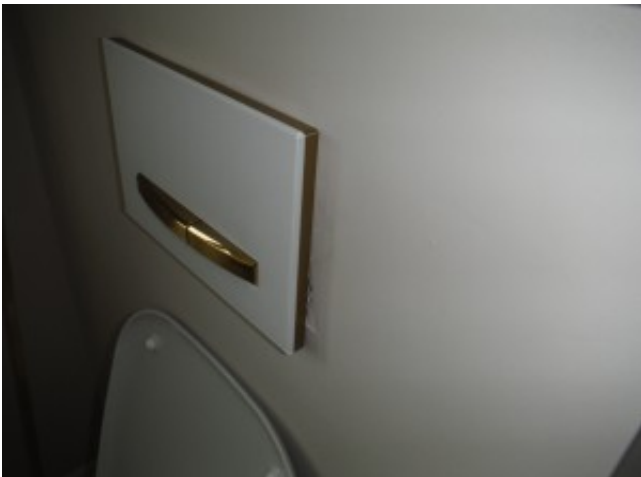
# 004 / 028

Poor finish around flush unit.

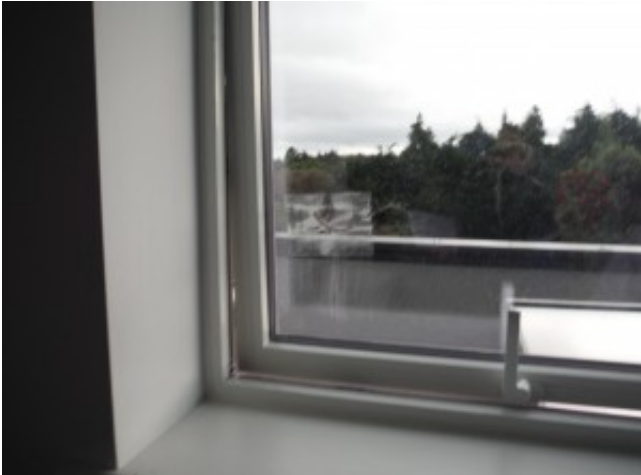
# 004 / 032

Windows where stickers were need cleaning.

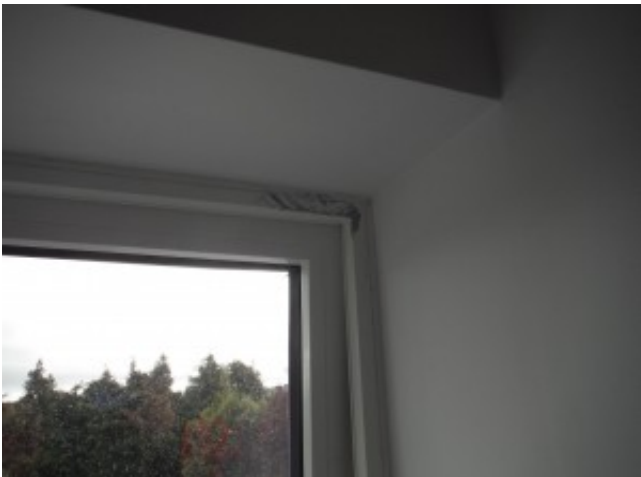
# 004 / 033

Damage to frame in bathroom window.

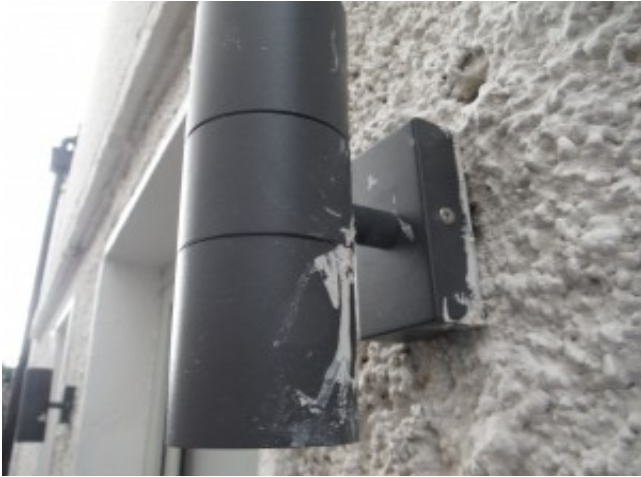
# 004 / 034

Paint splashes to light units

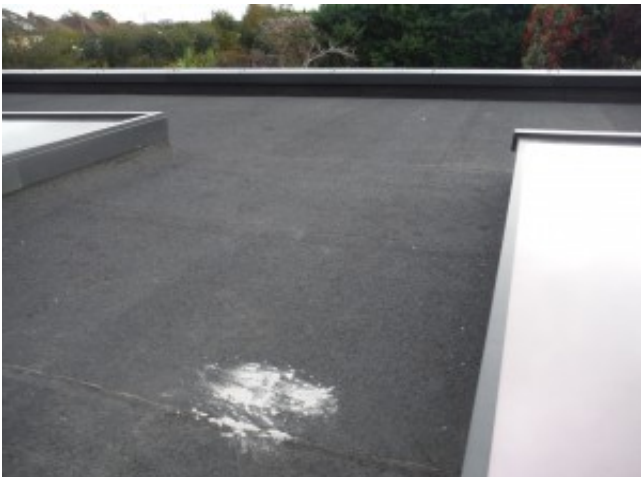
# 004 / 035

Clean material from roof.

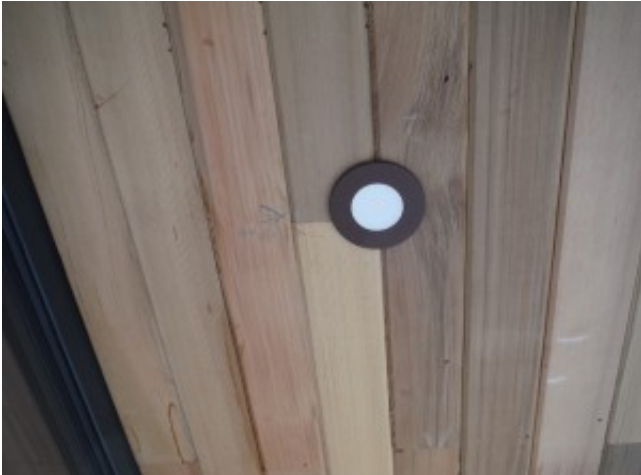
# 004 / 036

Again timber on underside of roof needs to be treated.

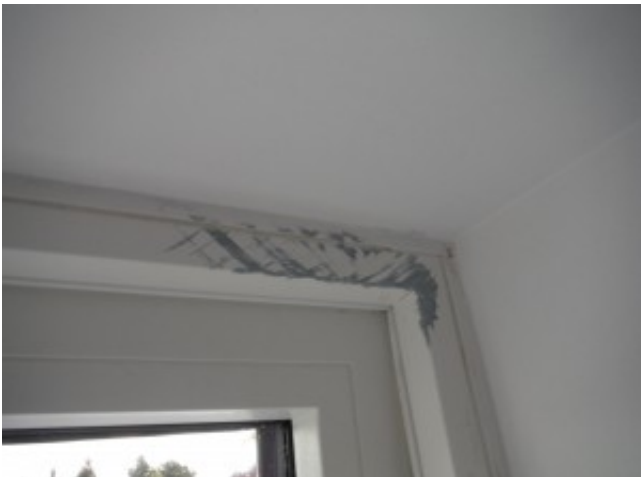
# 004 / 037

Damage to window frame.

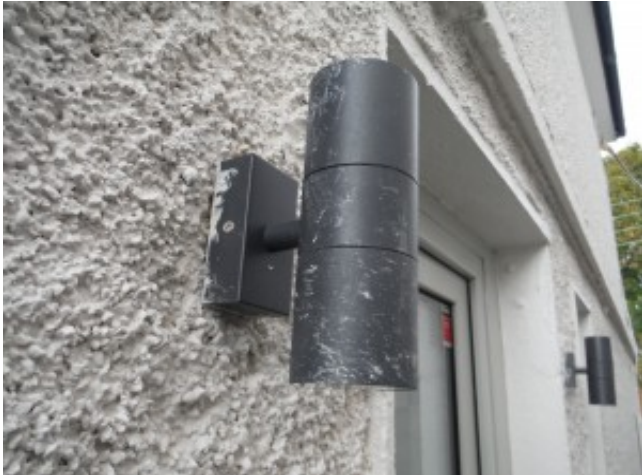
# 004 / 038

Paint splashes on light unit.

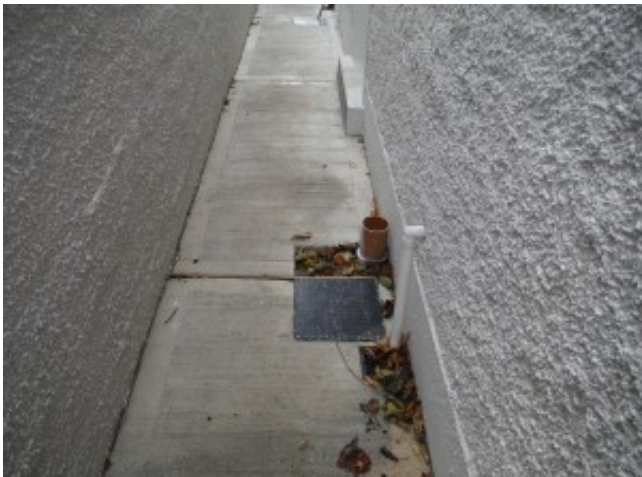
# 004 / 039

Soil vent pipe to be installed.

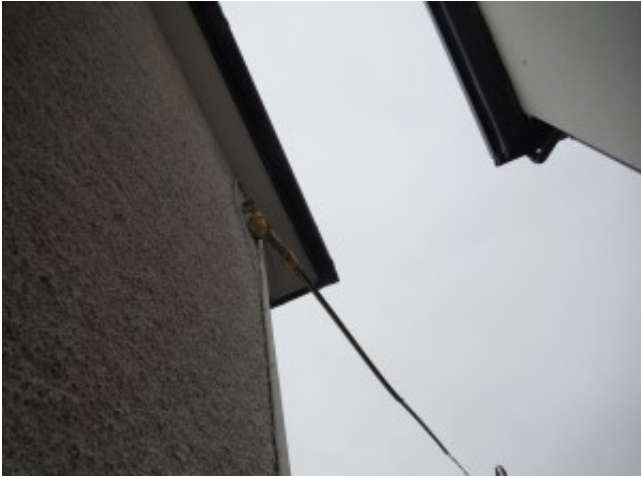
# 004 / 040

As mentioned before.

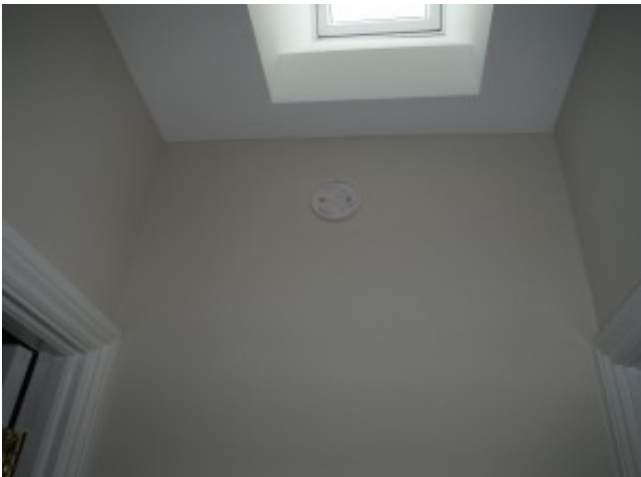
# 004 / 041

Not sure what should be installed here I am assuming a smoke alarm.

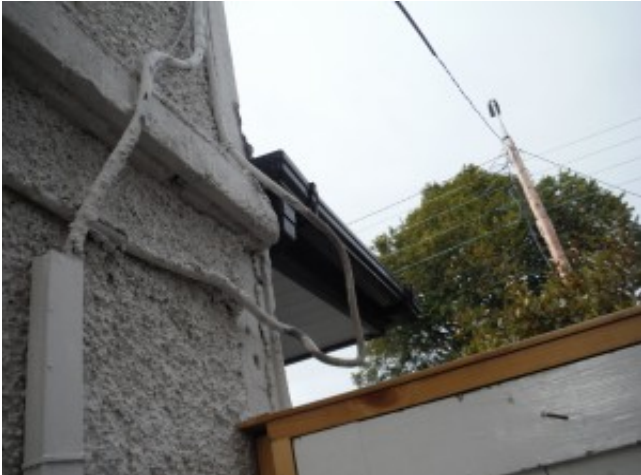
# 004 / 042

Side passage door to be painted and power cable as mentioned to be tidied.

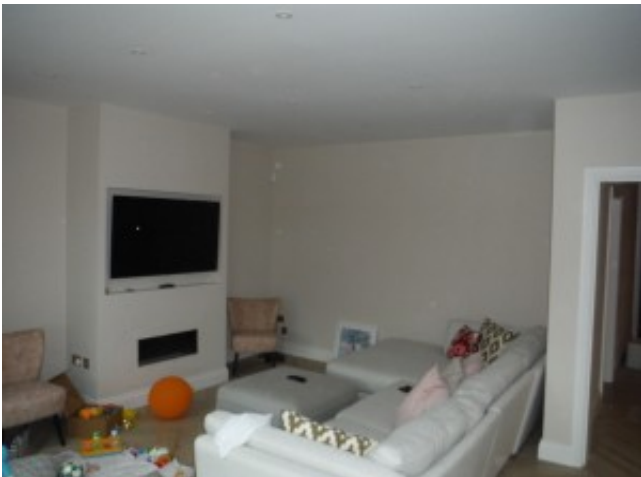
# 004 / 043

Fire surround protruding and edges are sharp. Needs attention.

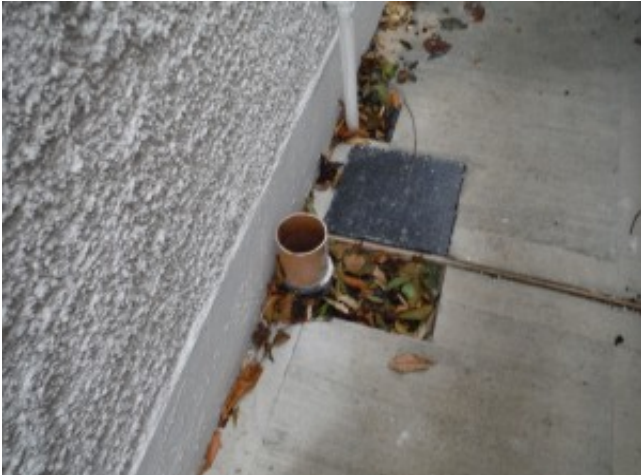
# 004 / 044

Again soil vent pipe to be installed.

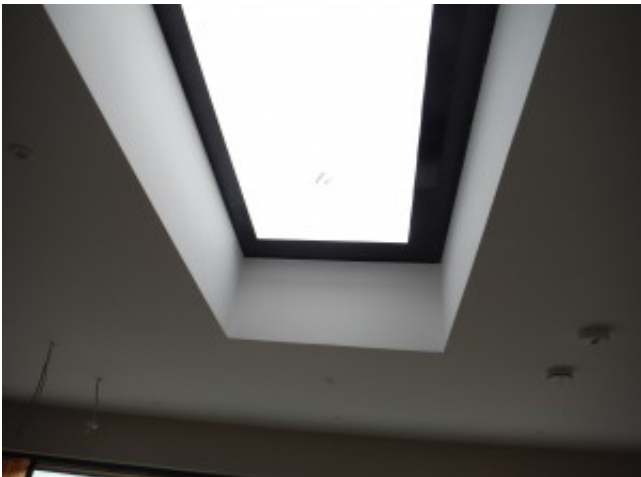
# 004 / 047

As mentioned.

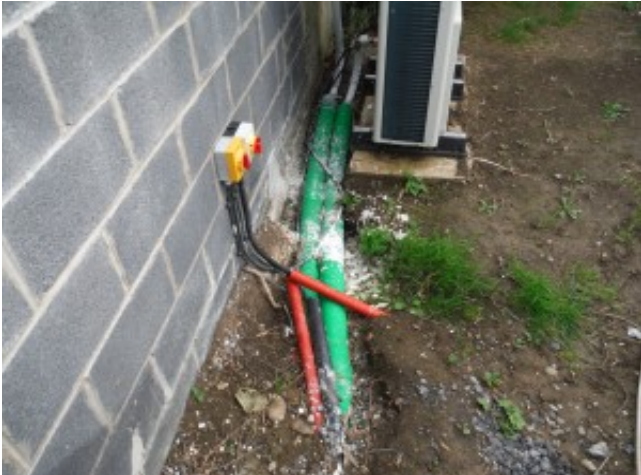
# 004 / 048

Exposed pipes need to be covered.  
There is an ongoing debate about finishes in this area.

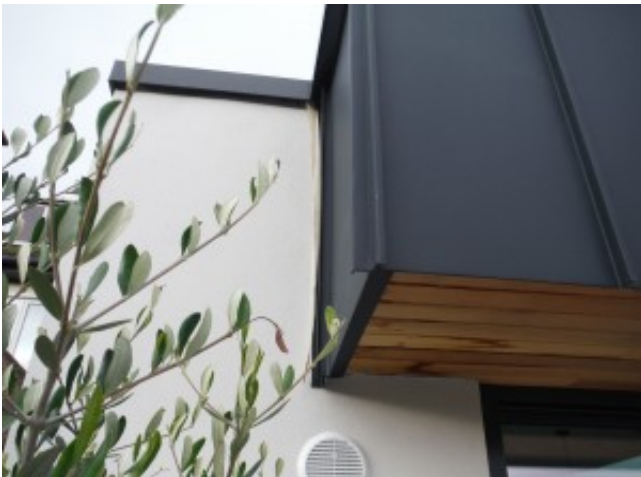
# 004 / 049

Masking tape to be removed at side of canopy.

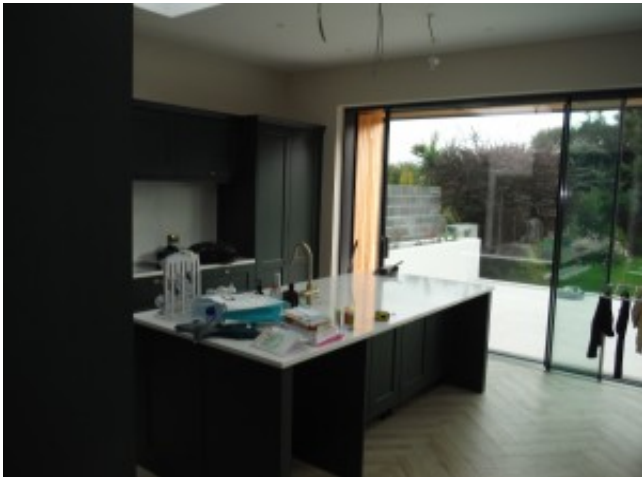
# 004 / 050

Second fix electrics ongoing.

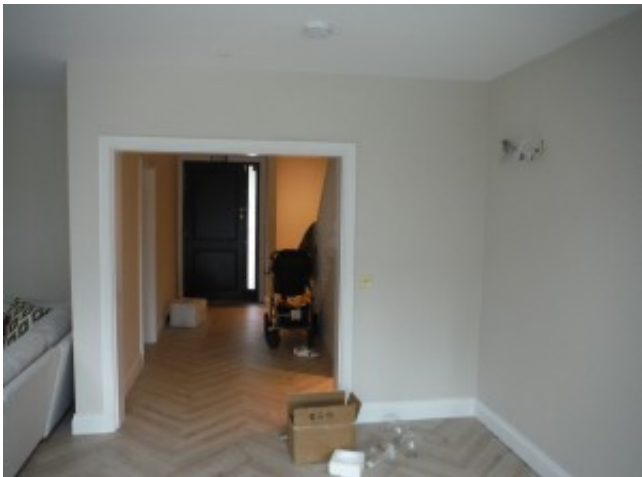
# 004 / 051

Flooring needs to be finished at skirting to the right of photo.

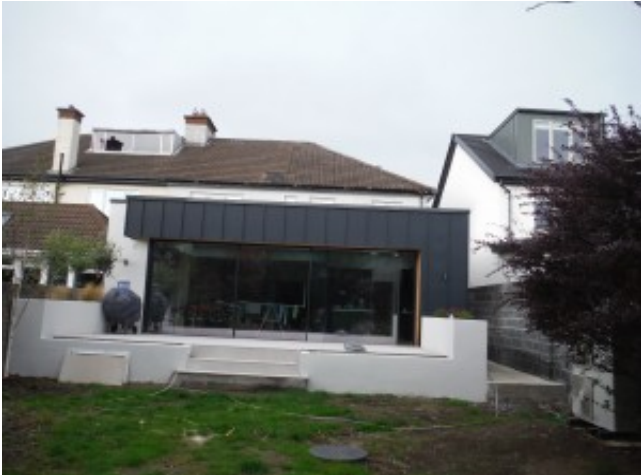
# 004 / 052

Height from the patio area to the garden/lawn area is currently too high. Garden will need to be raised to reduce height below 600mm or railing installed. Again ongoing debate on how to finish this item.
